Safety Bulletin

MS-5012 Limited Product Replacement

August 1, 2007 Document FLSB07-08-01

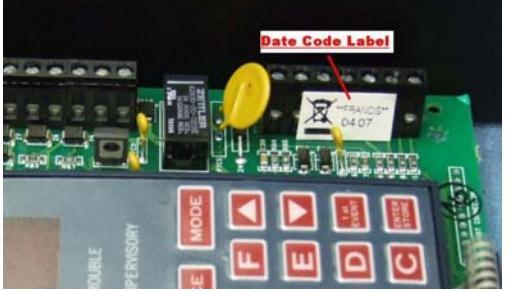
Please be advised that some MS-5012 panels produced from January, 2007 through May, 2007, may contain an incorrectly installed component. These panels must be returned to the factory for

credit and replacement. Customers can identify the affected range of installed products by locating the date code label installed on either of the two terminal blocks as shown in the photo. This date code will be in the range: 0207-1907 indicating product manufactured the second week of 2007 through the 19th week of 2007. An impacted panel will annunciate a local trouble with the local piezo trouble sounder activated upon failure. For those panels with enabled communicators, the 24-hour

test call to the central station will fail indicating non-operation. The display will indicate a continuously flashing number 8 (eight)". To avoid the potential of a field failure, all MS-5012 panels manufactured during this period must be replaced immediately.

Firelite will provide replacement boards through its normal distribution channel. Please call your Customer Service Representative to request an RMA and to place a new order for part number **5012RW.** Dealer/Installers must return the affected product to the distributor where it was originally purchased. Once a replacement part is obtained, please use the same packaging to return the original replaced board.
